Subject: 2010300074 - Winnebago County  
Soil Component Remedial Action Completion Report  
Source Area 4, Southeast Rockford Groundwater Contamination Superfund Site  
Rockford, Winnebago County, Illinois  
Superfund/Technical

**Soil Component Remedial Action  
Completion Report**

Source Area 4  
Southeast Rockford Groundwater  
Contamination Superfund Site

FINAL REPORT

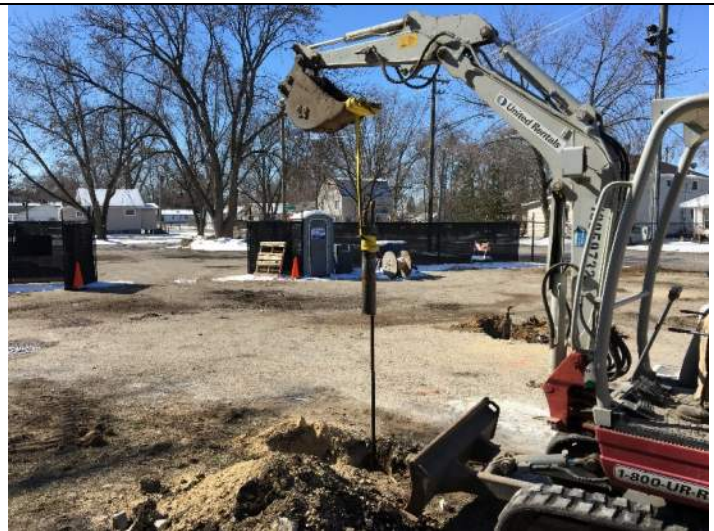
<b>Photo No.</b> <b>53</b>	<b>Date:</b> 03/15/2017	<b>Time:</b> 1115
<b>Direction:</b>  Southwest		
<b>Description:</b>  Once the pipes were cut on all of the MPE electrodes, TRS used the mini excavator to lift up on the cut piece of pipe so that the copper water entrainment pipe inside of the black iron steel pipe could be removed.

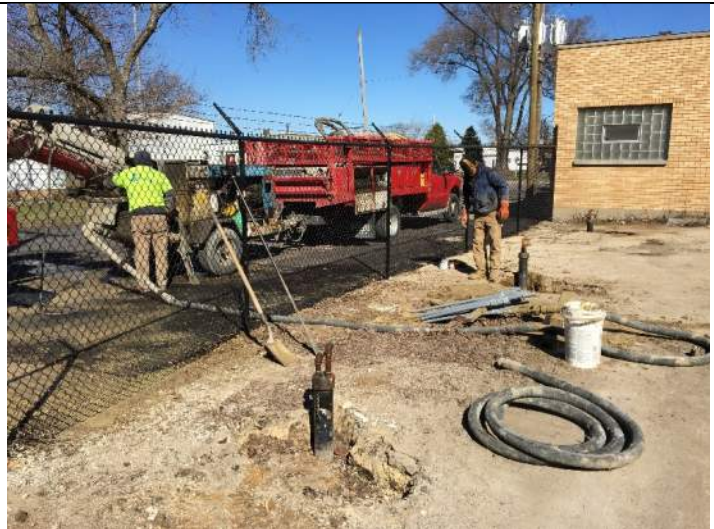
<b>Photo No.</b> <b>54</b>	<b>Date:</b> 03/22/2017	<b>Time:</b> 1055
<b>Direction:</b>  Northwest		
<b>Description:</b>  PJ's Concrete Pumping Services abandoned each below grade MPE electrode and monitoring point by forcing a concrete slurry through each CPVC pipe until it was completely filled.

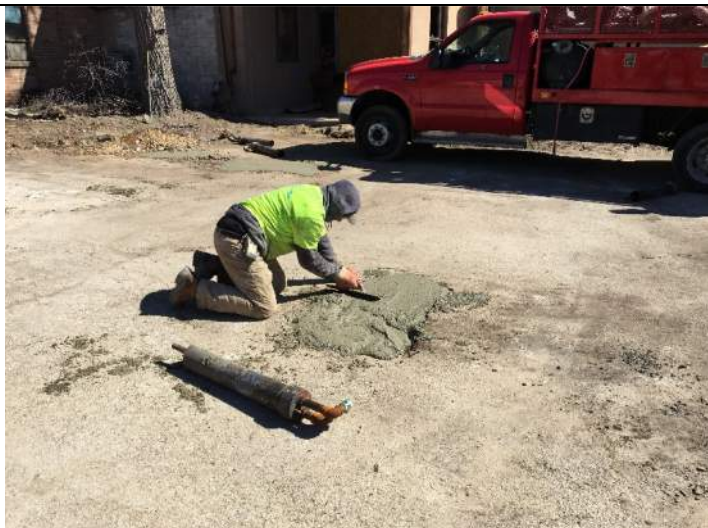
<b>Photo No.</b> <b>55</b>	<b>Date:</b> 03/22/2017	<b>Time:</b> 1144

<b>Direction:</b>  Northeast			
<b>Description:</b>  PJ's Concrete Pumping Services abandoned each above grade MPE electrode and monitoring point by pumping concrete into the well and filling in the area around the well up to the existing ground surface. Once the area was filled to existing ground surface, personnel smoothed out the concrete by hand.

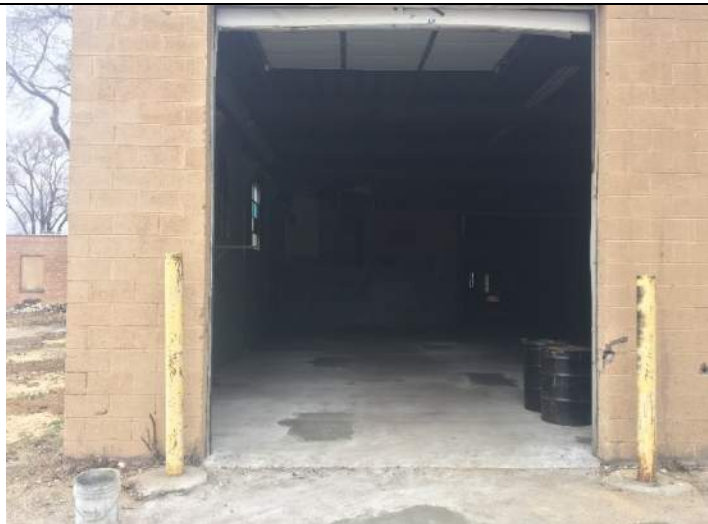
<b>Photo No.</b> <b>56</b>	<b>Date:</b> 03/23/2017	<b>Time:</b> 1321
<b>Direction:</b>  North		
<b>Description:</b>  Two drums of spent carbon were stored inside of the building until they were hauled off and properly disposed of on April 28, 2017.

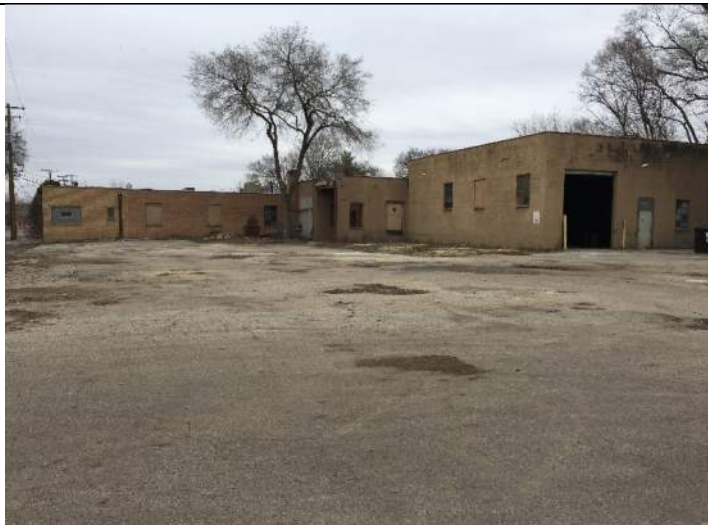
<b>Direction:</b>  Northeast			
<b>Description:</b>  Area 4 was returned to existing site conditions on March 23, 2017.

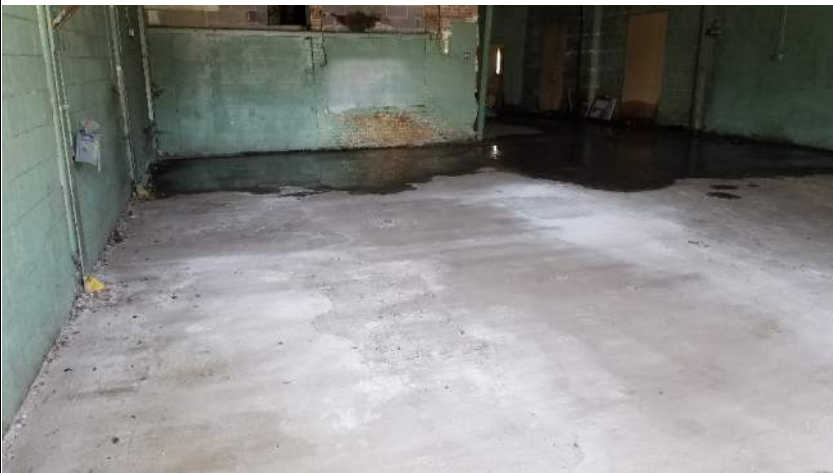
<b>Direction:</b>  North			
<b>Description:</b>  All of TRS's equipment and waste was removed from the building, except for the 2 spent carbon drums.
